MARINE SAFETY INVESTIGATION REPORT

Safety investigation into the collision involving the
Maltese registered bulk carrier

GORTYNIA

DZ QINGDAO

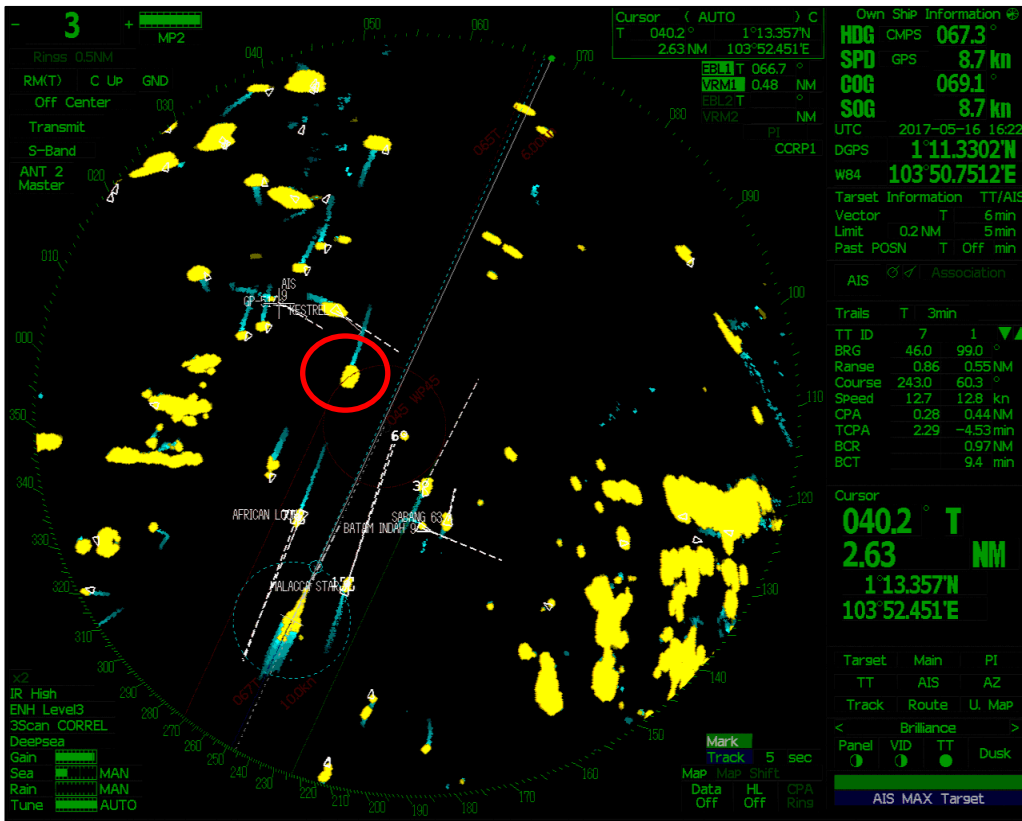
At about 0022, the AIS vector of *DZ Qingdao* disappeared from the S-band radar of *Gortynia*⁶ (Figure 9). The AIS symbol (triangle) reappeared at around 0023, but had no directional vector (Figure 10).

⁶ The AIS data recorded by *Gortynia*'s VDR indicated no AIS signal from *DZ Qingdao* from 0021:25 to 0023:19 - a duration of about 1 minute 55 seconds.

Figure 9: AIS vector of DZ Qingdao disappeared

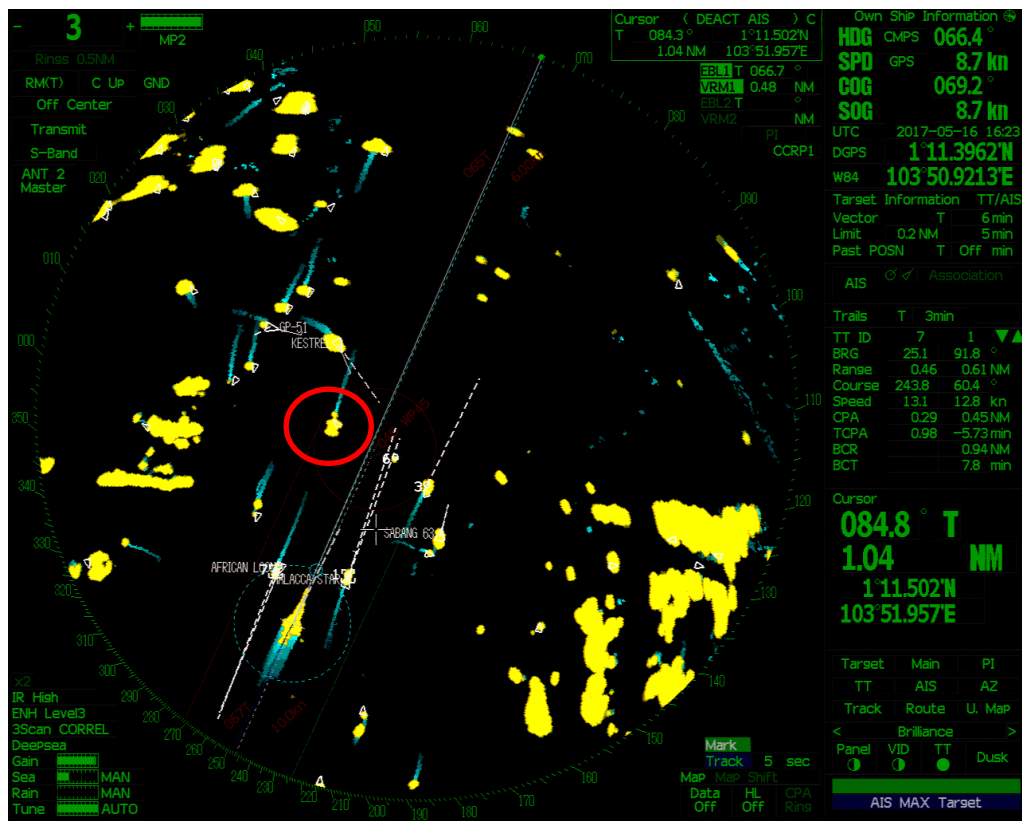
Figure 10: AIS symbol reappeared but with no vector

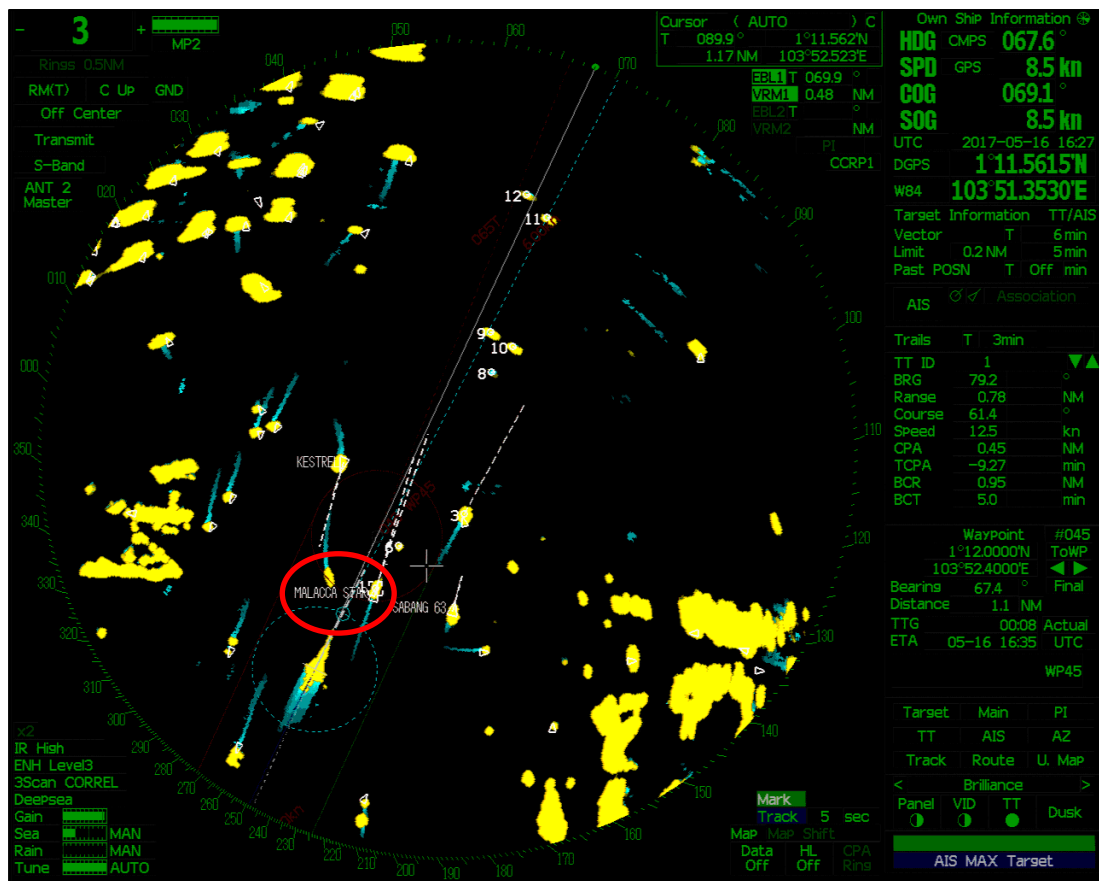
This message was acknowledged by *DZ Qingdao* at 0027:08 when *Gortynia* was about six cables distant (Figure 11).

Figure 11: *DZ Qingdao* at 0027, about six cables distant

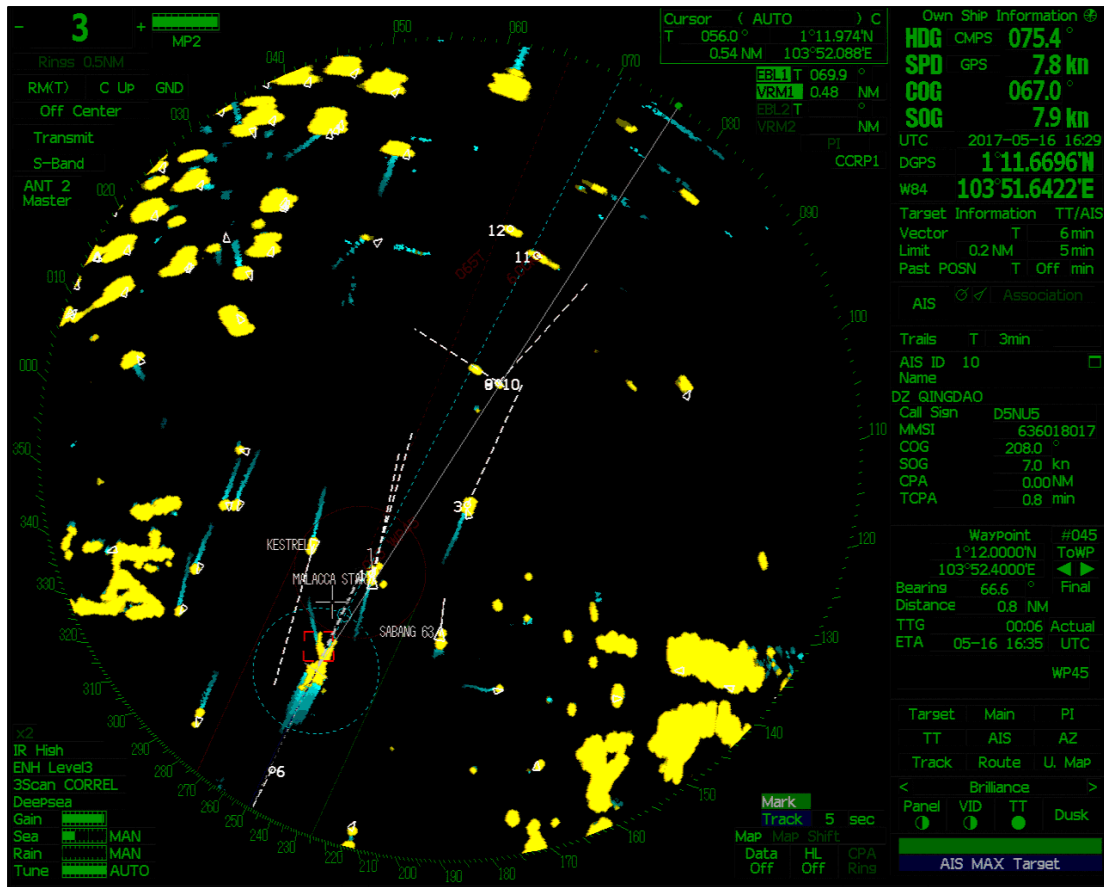
The bridge team members on *Gortynia* reported seeing the masthead light and the red side light, which changed to green. At about 0029:30, *DZ Qingdao* hit *Gortynia* in position 01° 11.66’ N 103° 51.64’ E (Figure 12). At the time of the collision, *DZ Qingdao*’s course and speed respectively were 208° and seven knots.

Figure 12: Collision in position 01° 11.66' N 103° 51.64' E

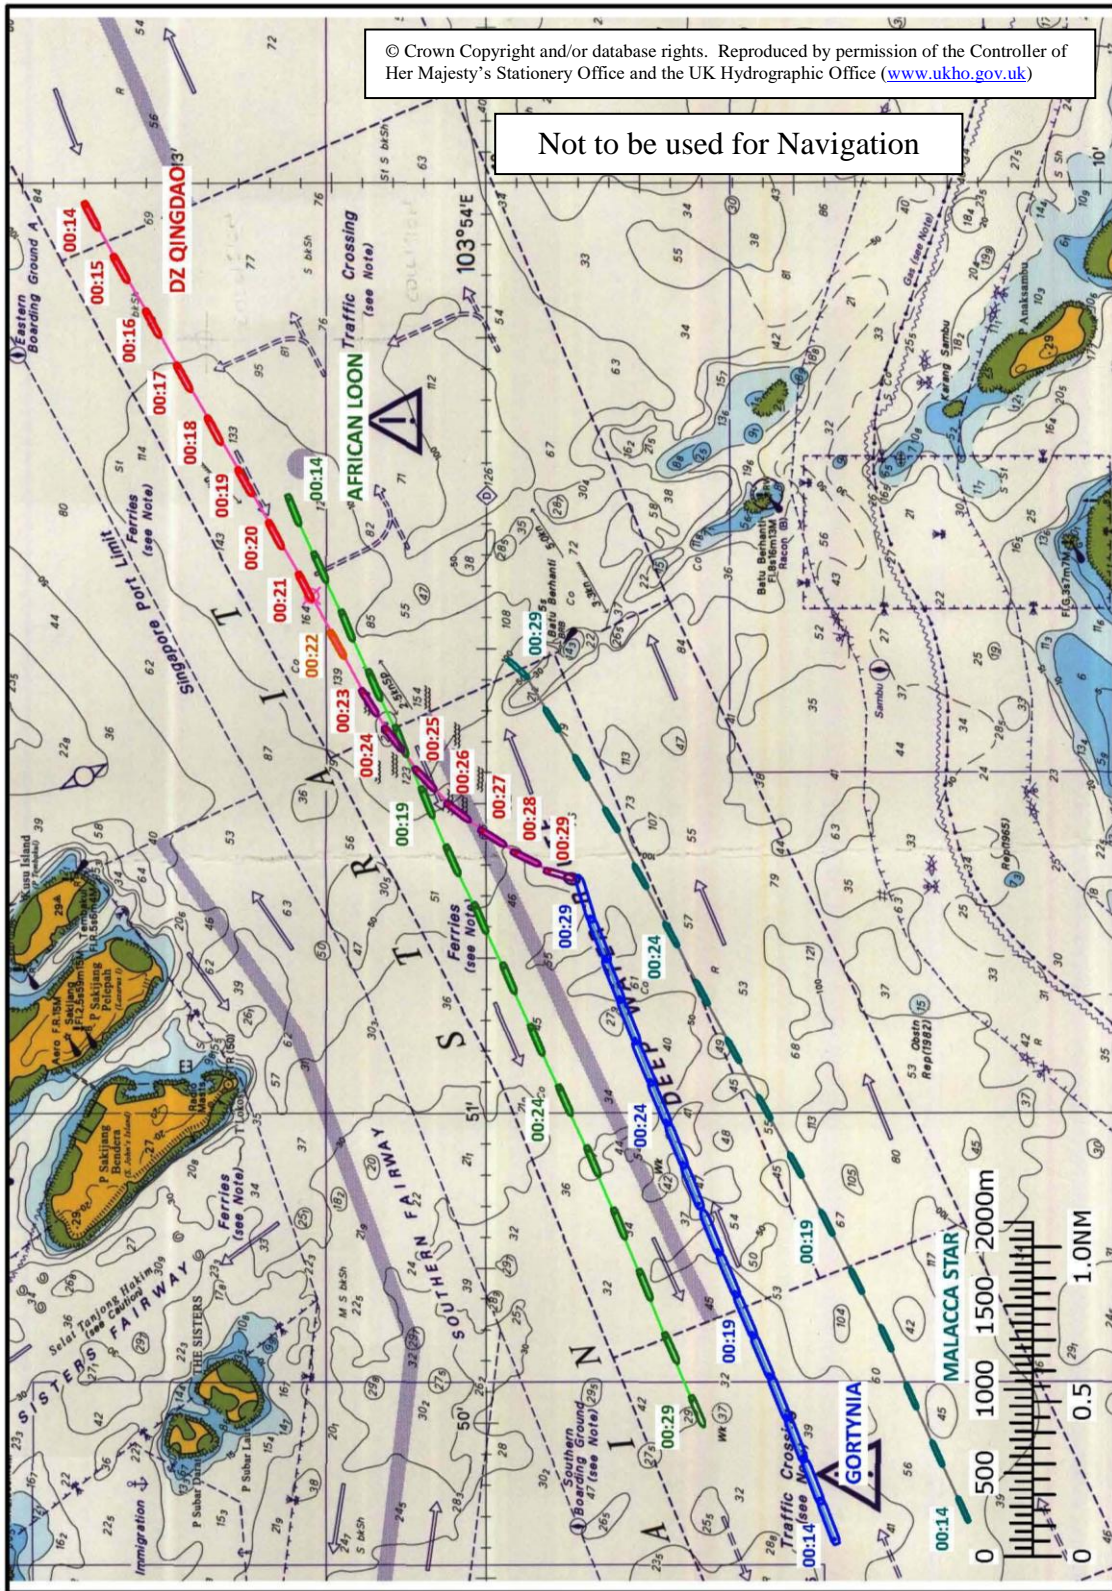
Figure 13: Collision plot on extract of BA Chart 4041

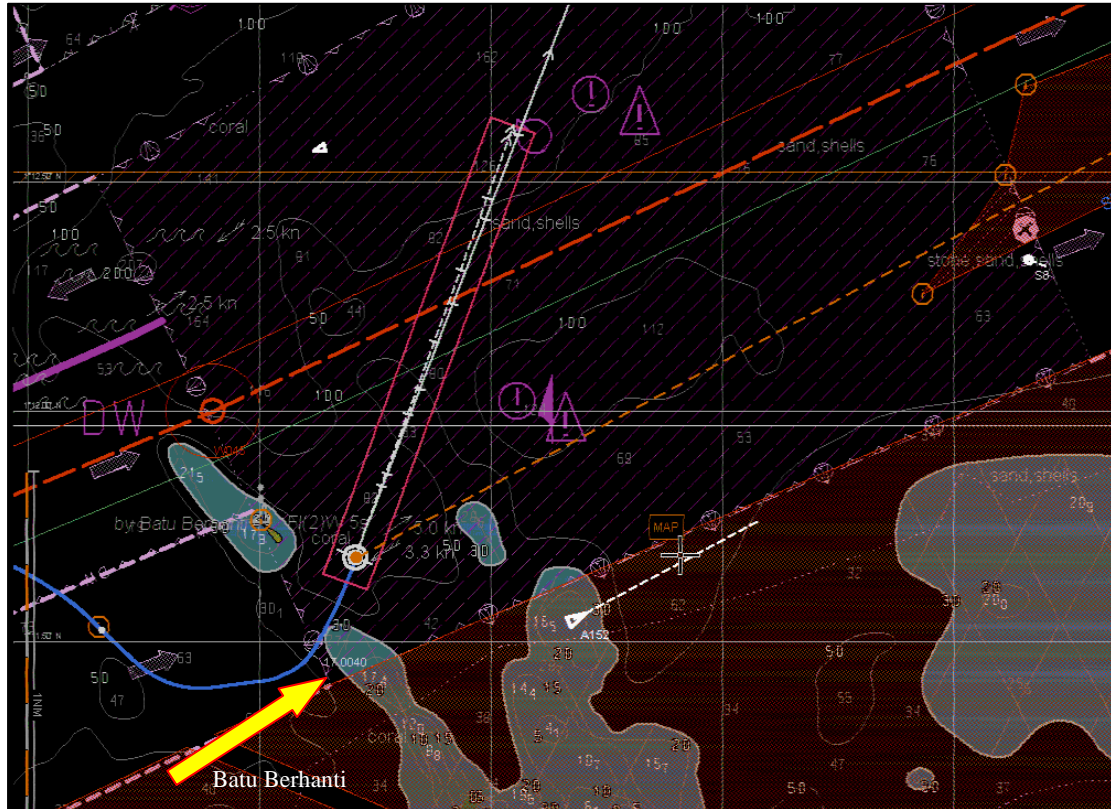
Following the collision, the master reported the collision to VTIS at 0031. He then concentrated his efforts in controlling the vessel's movements and avoid the shallow waters off Batu Berhanti (Figure 14). The vessel avoided running aground and cleared the bank at about 0040.

Figure 14: Vessel's track following the collision with *DZ Qingdao*

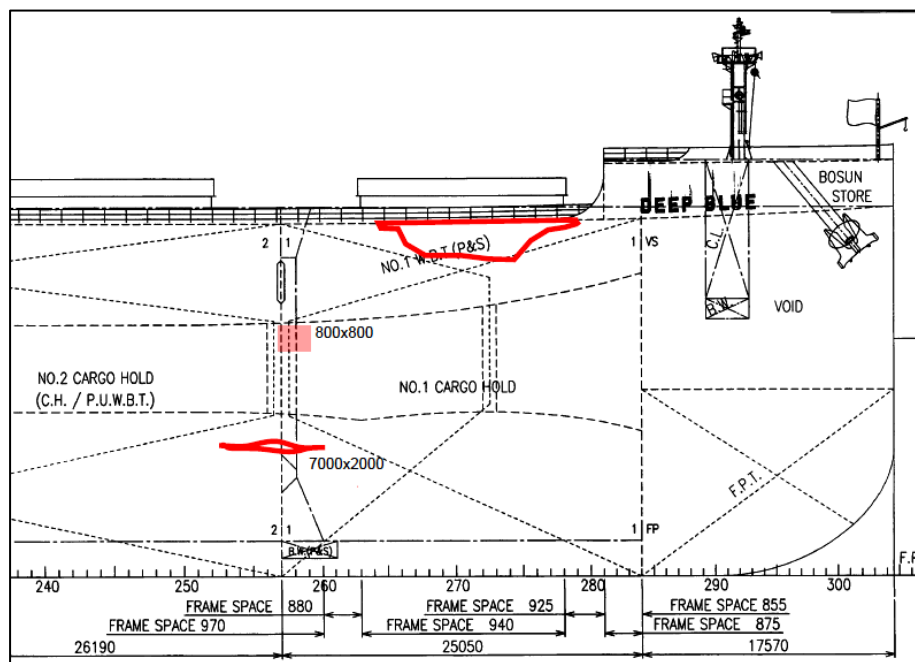
Gortynia sustained extensive damage to her hull in way of port side ballast tank no. 1, which included:

- breach of the upper topside tank and double bottom (Figures 15 and 16);
- cracks in the side shell plating, in way of cargo holds nos. 1 and 2;
- buckling of the shell plating and fish plate extending from frames nos. 41 to 263;
- deformation of web frames in way of the above mentioned damage;
- damage to deck railings and fittings at various locations (port side);
- damage to the hatch cover opening railway (port side);
- damage to various ballast and fuel oil tanks vent heads; and
- fuel oil hose handling davits (port side).

Figure 15: Damaged areas to *Gortynia*, in way of port side ballast tank no. 1

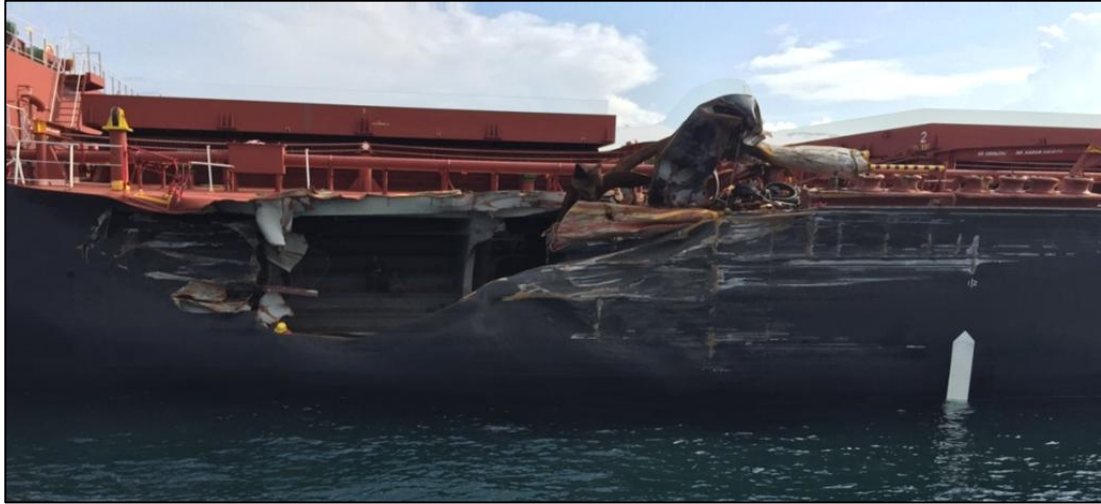
Figure 16: Point of contact and extreme damage section on *Gortynia* (port side)

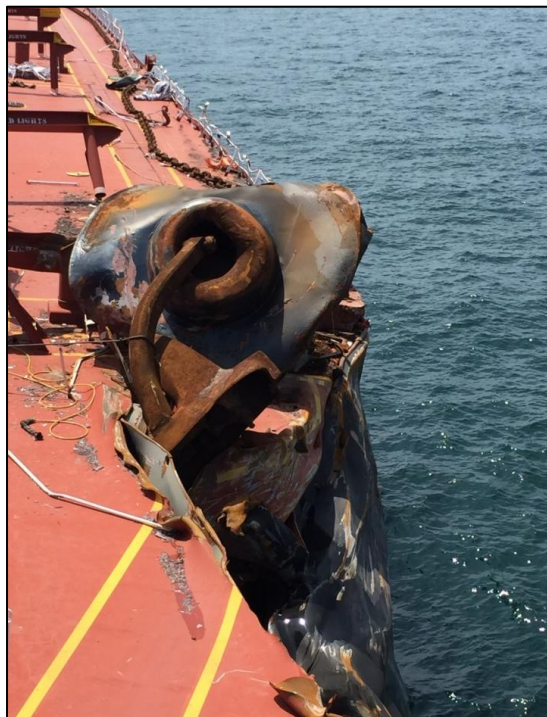
DZ Qingdao sustained considerable hull damage from her port bow to her bulbous bow, and from the fore peak tank to no. 1 port ballast tank. The forecastle deck plating was fractured, the bulbous bow was heavily distorted with severe bends and fractures and there were several lacerations on her underwater hull. The port anchor with six shackles of anchor chain was detached and stuck on to the port side of *Gortynia* (Figure 17).

Figure 17: Detached section (anchor and anchor chain) of *DZ Qingdao* on *Gortynia*'s deck
