MARINE SAFETY INVESTIGATION REPORT

Safety investigation into the collision involving the
Maltese registered ro-ro vessel
NEPTUNE HELLAS
and the Cook Islands registered general cargo vessel
NUR
in the West lane of the Turkish Straits TSS
Marmara Sea
on 21 March 2018

MARINE SAFETY INVESTIGATION REPORT NO. 05/2019

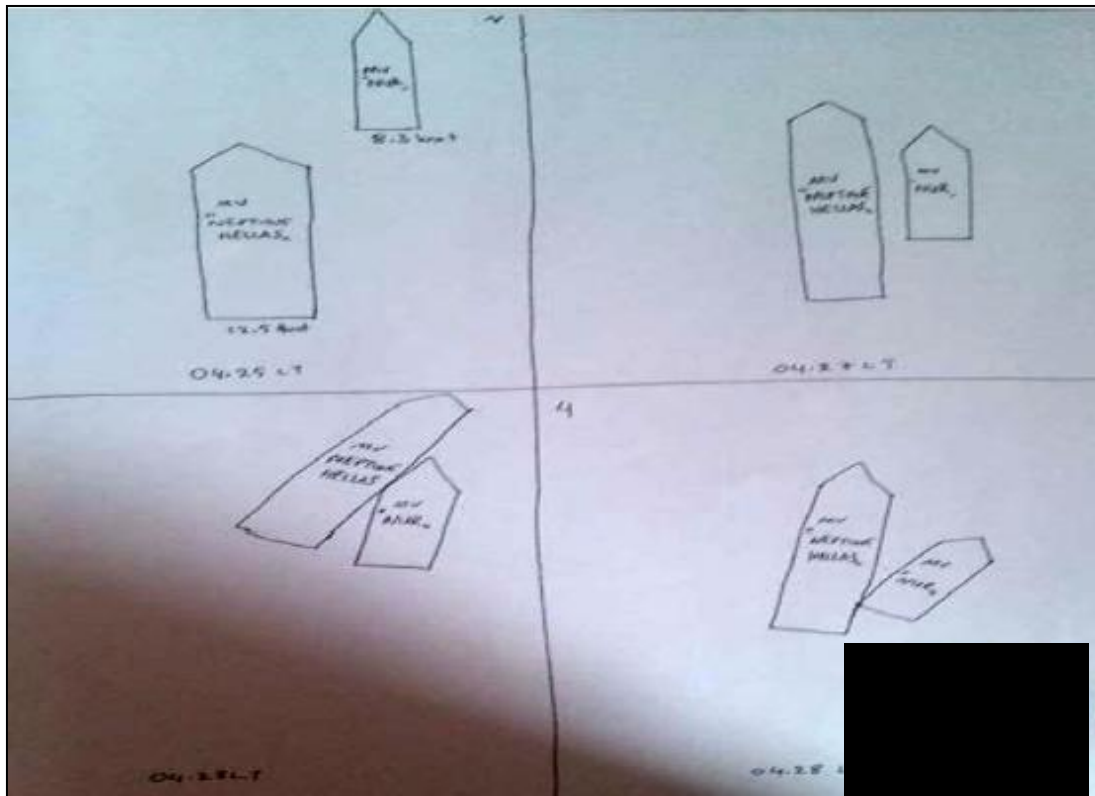
Figure 6: A sketch prepared by the master of *Nur* to explain the collision between the two vessels

The chief mate stated that *Neptune Hellas* made a sudden alteration to starboard while she was overtaking *Nur* on the latter's port side (Figure 6).

According to the chief mate, *Neptune Hellas*' contact with *Nur*'s port side bow was followed by a second contact between *Nur*'s port aft quarter and *Neptune Hellas*' starboard stern quarter.

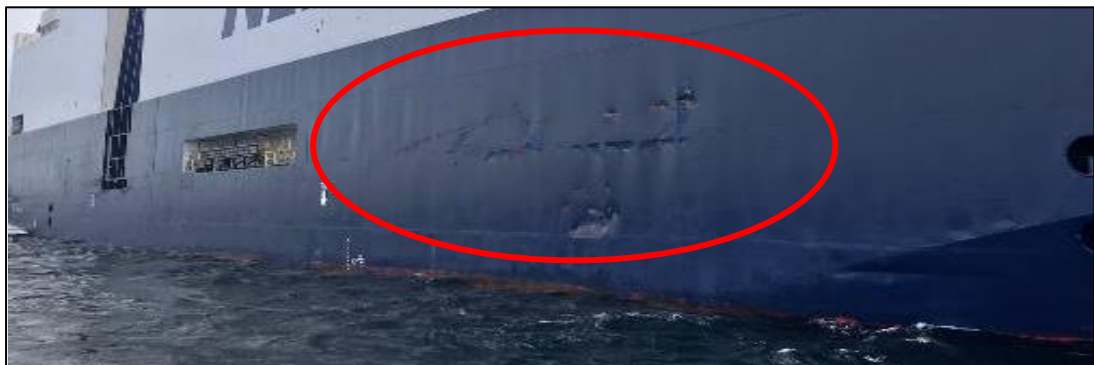
Figure 12: Damages in way of starboard side shell plating

As a result of the collision, structural damages, including ruptures, indentations and paint scratches were observed in way of starboard side shell plating of *Neptune Hellas* and above the waterline (Figure 12).

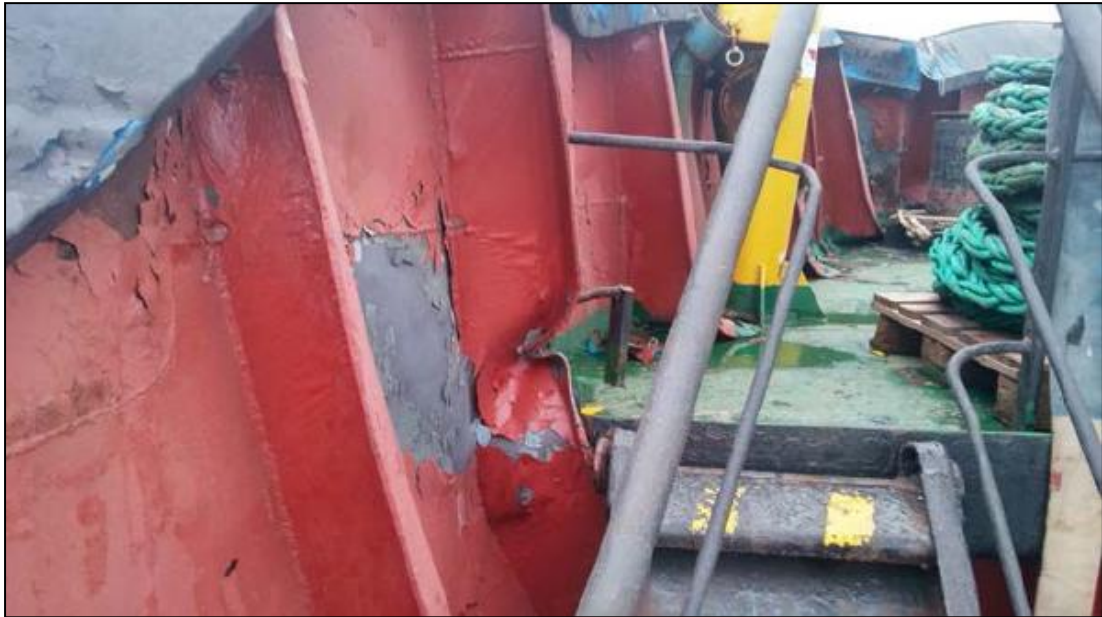
Figure 13: Damages to the forecastle deck

Structural damages were observed on the vessel (Figures 13 and 14).

- forecastle deck plating with associated framing in the bow area in way of frames 111 to 127;
- bulwark with guard rails and reinforcement on the forecastle deck in the bow area, in way of frames 4 to 15;
- side shell plating on port side and associated framing in way of frames 114-127 and the aft end in way of frames 4 to 15;
- air ventilation, sewage and sounding pipes and associated leakage protection boxes in the bow, port side and poop deck areas;
- mooring equipment (hawse pipe, bollard, roller and fair leads foundations on the forecastle and poop deck;
- air condition room side shell plating scuttle on the port side;
- guard rails on the poop deck – port side; and
- poop deck plating and associated framing in way of frames 4 to 15.

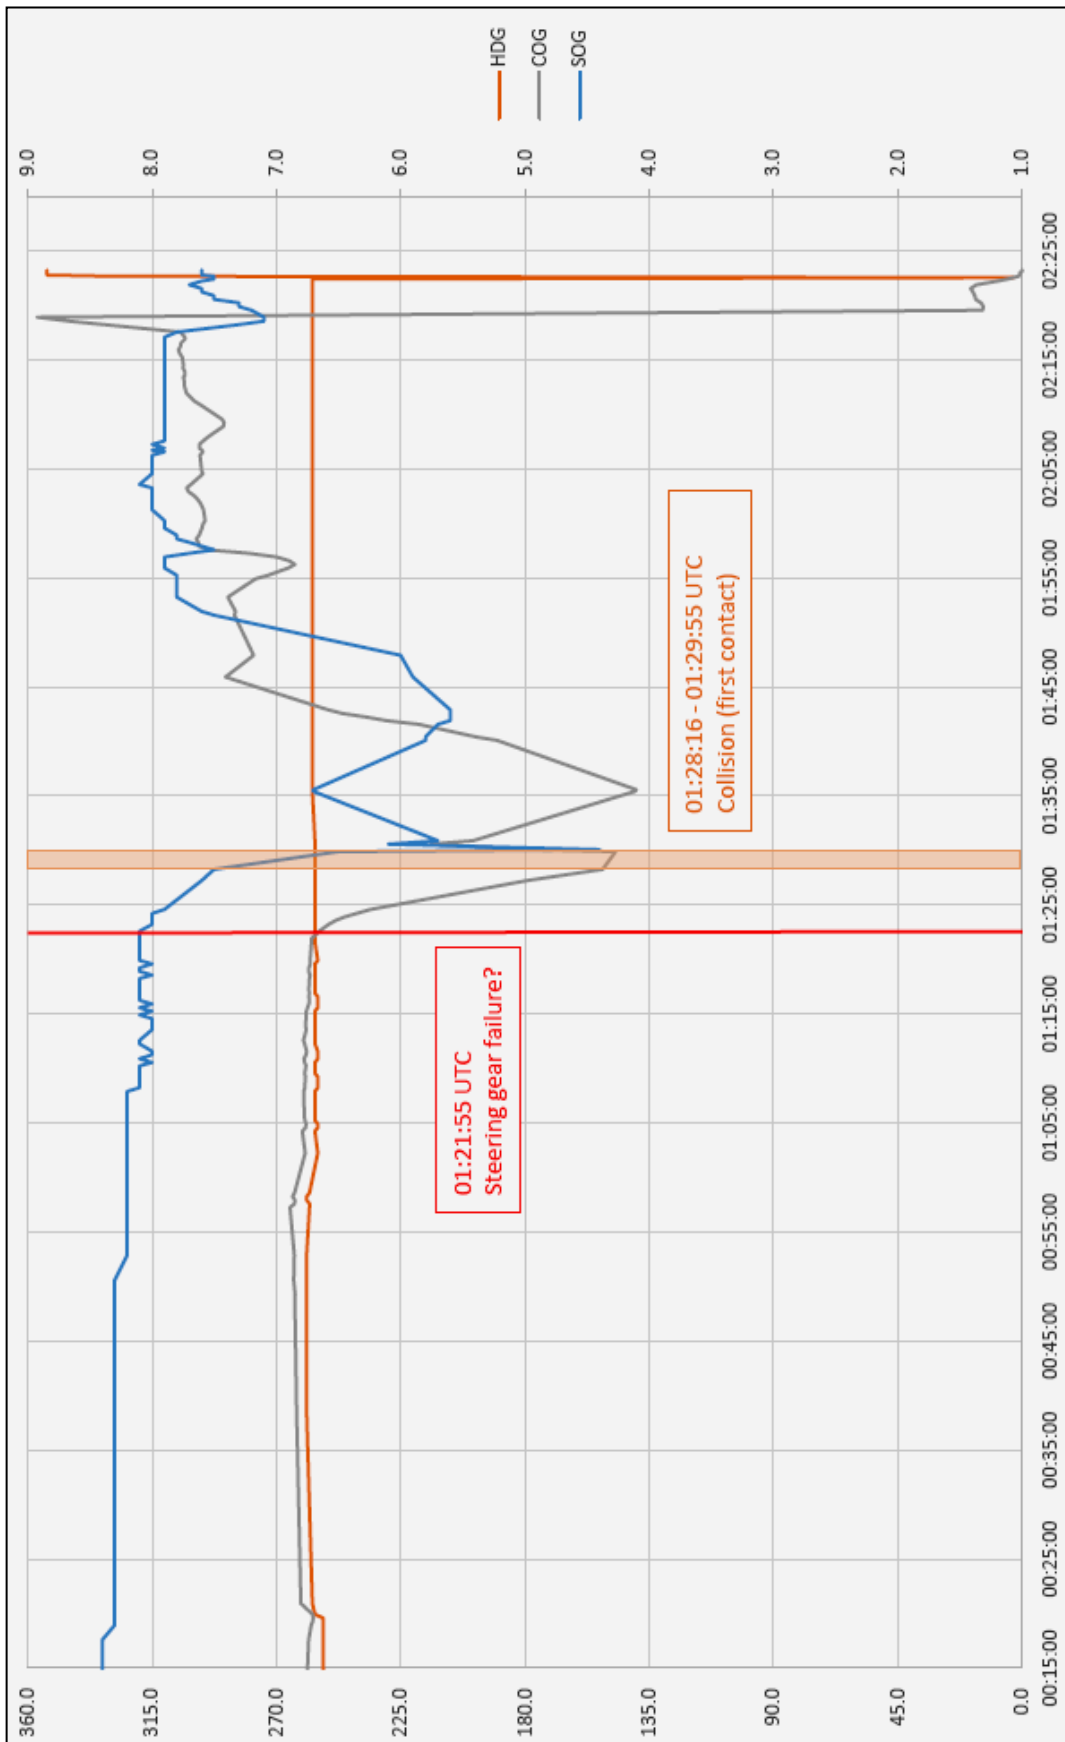
Figure 15: Nur's AIS data analysis and COG graph

In November 2018, during the course of this safety investigation, *Nur's* AIS position analysis (Figure 15) was submitted to the MSIU. According to this data analysis, the steering gear system on board *Nur* had malfunctioned at 0121:55 (eight minutes before the collision) and this failure accounts for the vessel's abrupt swing to port until her contact with *Neptune Hellas* (Figure 15). The heading marker line which is logged steady on 256° was reportedly due to an error in the transmission of gyro data to the AIS. This sudden and unexpected change of direction was neither reported by *Nur* nor anticipated by *Neptune Hellas*, which significantly altered the conditions under which *Neptune Hellas* was overtaking *Nur*; leaving no time for the OOW to effectively manoeuvre her out of the way.
