MARINE SAFETY INVESTIGATION REPORT

Safety investigation into the collision involving the
Maltese registered bulk carrier

GORTYNIA

DZ QINGDAO

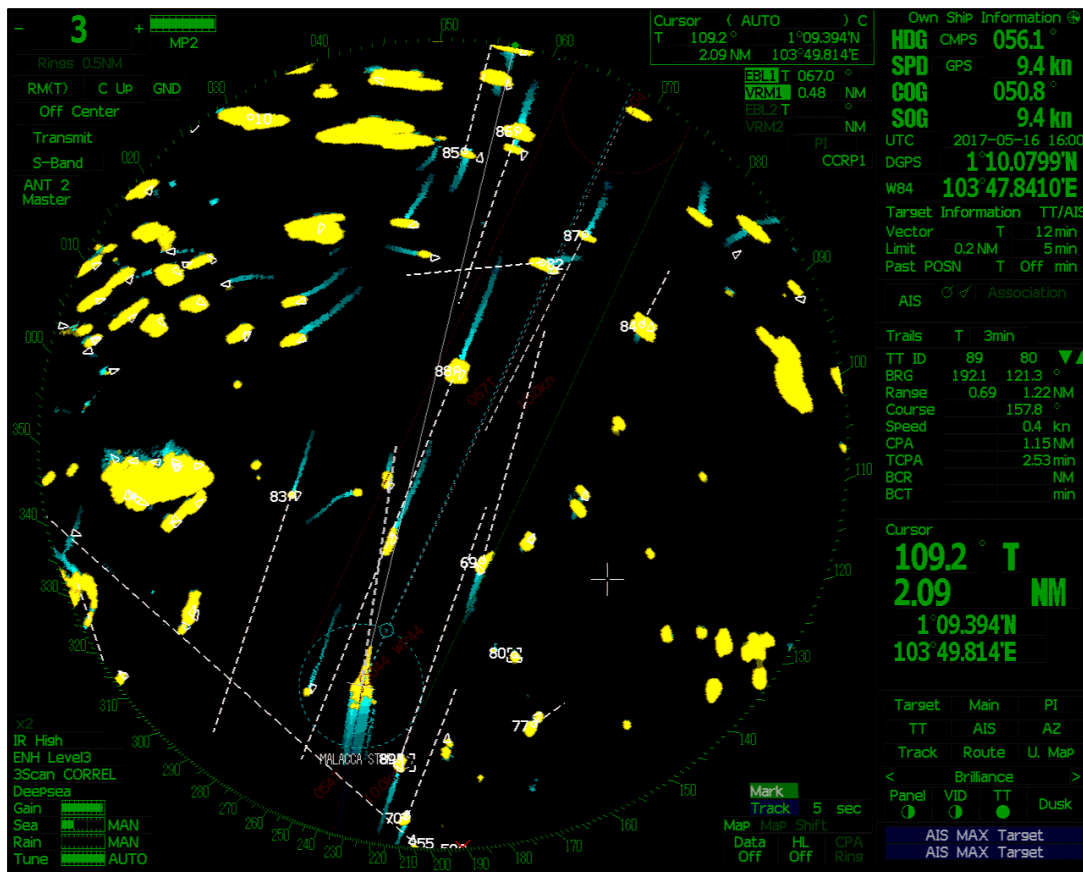
At 0000 on 17 May, the chief mate and the second mate took over the watch from the third mate. The AB on the wheel was also relieved and the vessel continued to be manually steered. The chief mate was tasked with anti-collision duties, while the position fixing and monitoring of the vessel's planned track were delegated to the second mate. The master retained the con of the vessel and the third mate and the cadet remained on the bridge. The estimated time of arrival (ETA) to PEBG B was 0100 and the traffic in the immediate vicinity was heavy (Figure 6).

Figure 6: *Gortynia*'s radar screen showing her in the deep water route at 0000

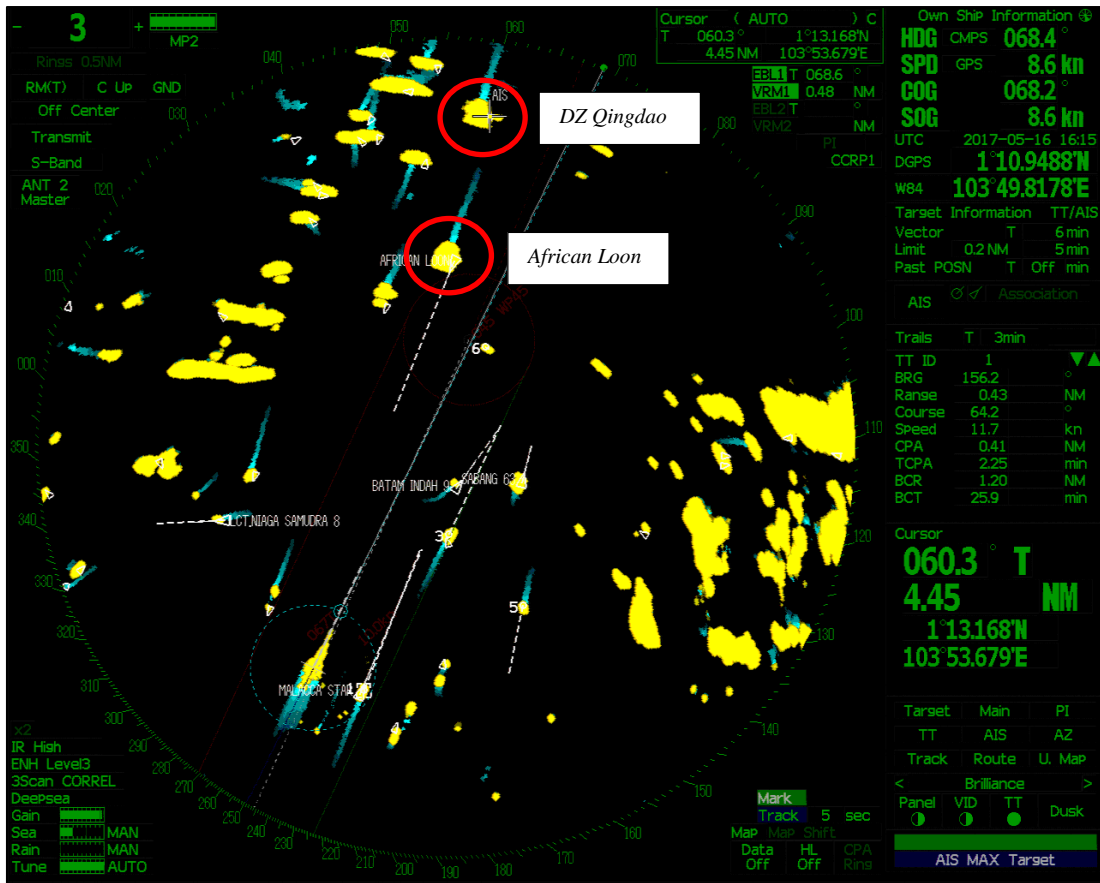
Figure 7: *DZ Qingdao*'s target acquired by chief mate

Gortynia's heading and speed were 068.4° and 8.6 knots respectively. *DZ Qingdao* was about 4.4 nm distant. The subsequent AIS plot of *African Loon* at 0016 indicated that it would pass *Gortynia* at about four cables on the port side. It was stated by the chief mate that it was normal for vessels to pass within two to three cables in the Singapore Strait. *DZ Qingdao* was following the *African Loon* in the Westbound traffic lane. At the same time, *Malacca Star* was overtaking *Gortynia* on her starboard side with a closest point of approach (CPA) of about four cables (Figure 7).

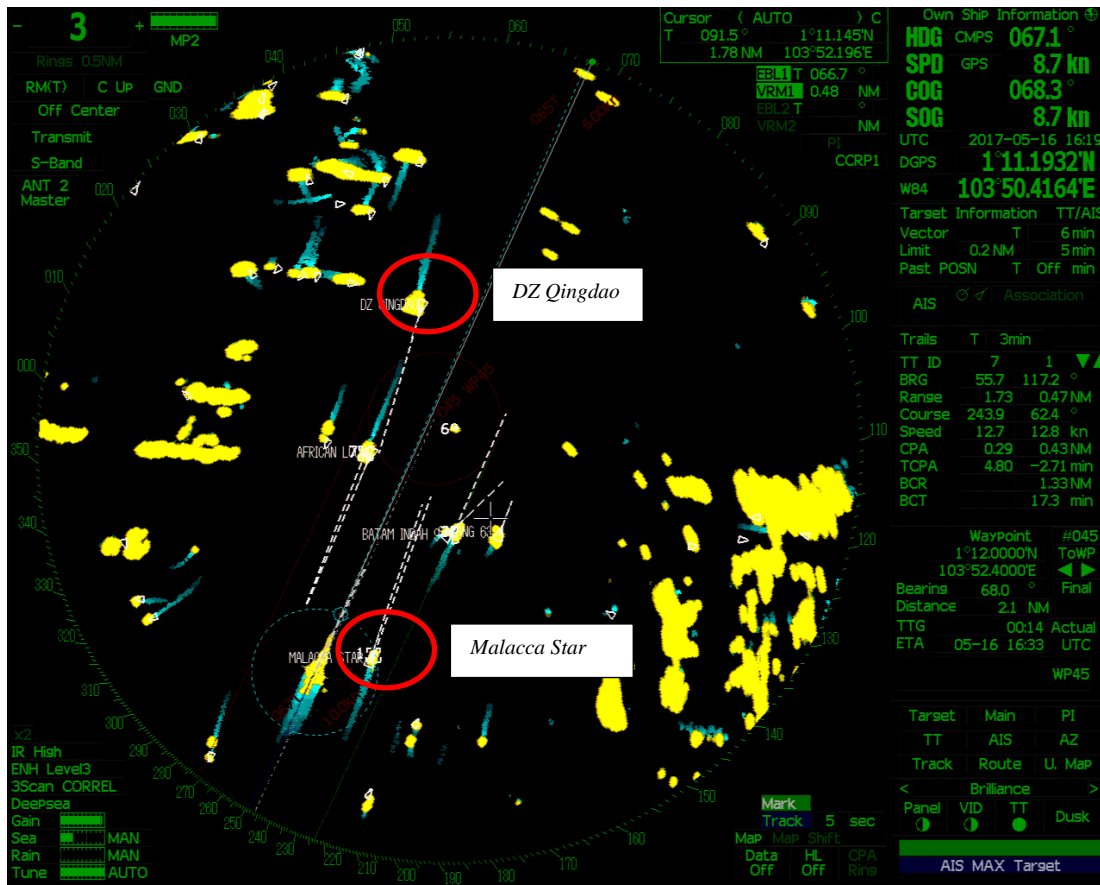
At about 0020, *DZ Qingdao* was about 2.9 nm distant and the vessel's AIS vectors continued to indicate that she would pass clear of *Gortynia* (Figure 8).

Figure 8 – *DZ Qingdao*'s target at 0020
